**Flood Control Project Maintenance
Levee Inspections**
LMA District Cover Sheet
Spring 2019 Levee Inspection Results

Reclamation District No. 2075 McMullin

Spring 2019 Levee Inspection Results

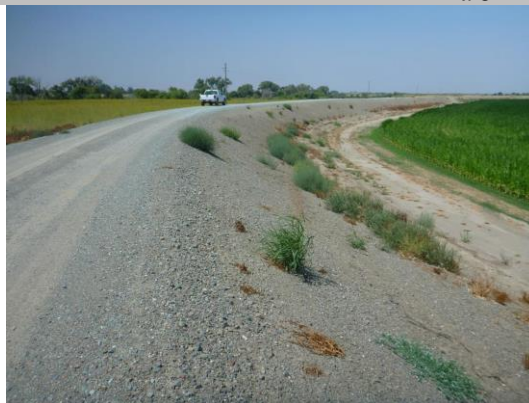
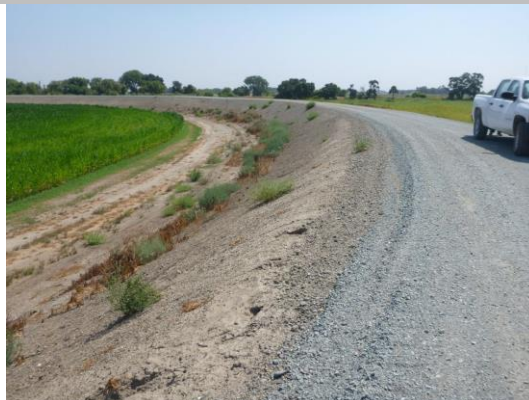
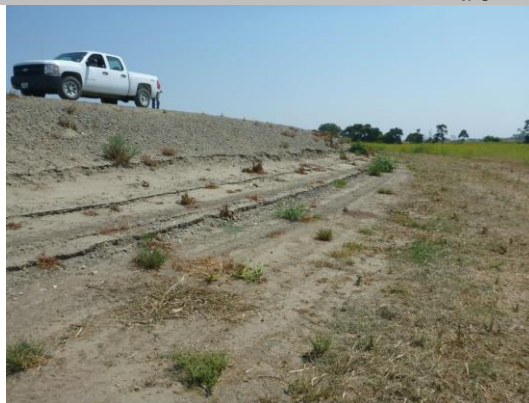
Comment Code					
Inspector Comment					
Levee Evaluation Comments					
Description:Slope protection repairs are needed along the waterside slope due to erosion and riprap displacement from high water. Based upon levee inspections, it was determined the waterside levee slope is eroding, deteriorating, and degrading. The eroded levee sections need to be restored back to design standards to prevent further deterioration and damage.					
Site ID No:576					
Site Designation:LMA-482					
Repair Type: Erosion					
Rating:Area of Concern					
Field Date:8/10/2017					
Notes: 10/23/17: There was no riprap in this area. Erosion sites have been repaired by LMA.

Description: Slope protection repairs are needed along the waterside slope due to erosion and riprap displacement from high water. Based upon levee inspections, it was determined the waterside levee slope is eroding, deteriorating, and degrading. The eroded levee sections need to be restored back to design standards to prevent further deterioration and damage.

Notes: 10/23/17: There was no riprap in this area. Erosion sites have been repaired by LMA.

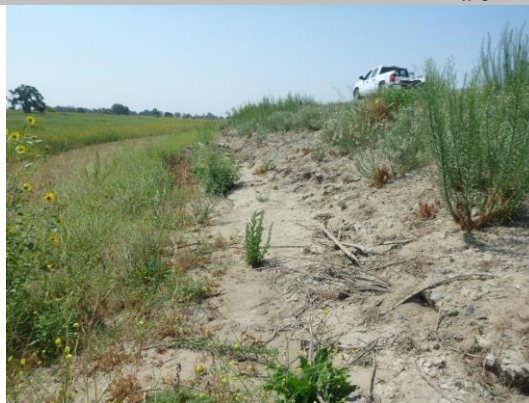
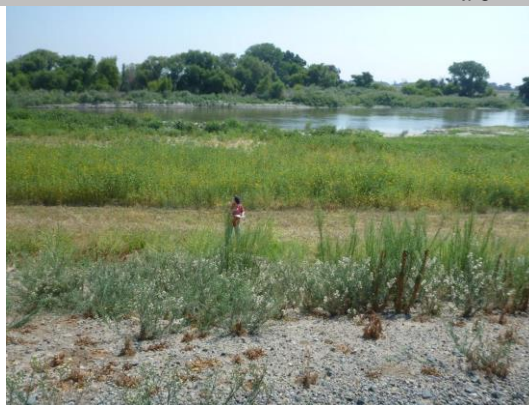
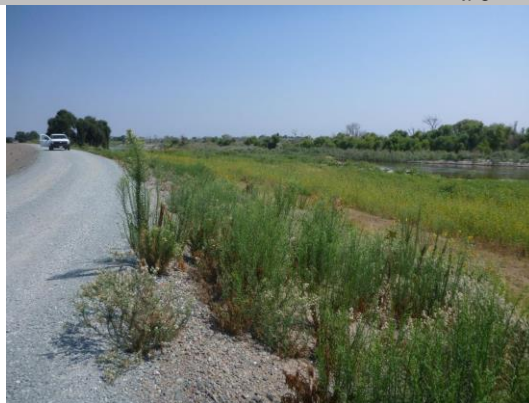
LM Start	4.00	Rating **	A/W	Issue No.	19							
LM End	4.04	Issue Type +	Ma	Location *	WS							
Category	Supplemental		GPS Latitude/Longitude									
			Start	End								
Item	2017 Storm Damage		37.714048 °	37.714630 °								
			-121.278363 °	-121.278263 °								
DWR ID	DWR_RD2075_01_f_2017_19											
Comment Code												
Inspector Comment												
Levee Evaluation Comments Description: Slope protection repairs are needed along the waterside slope due to erosion and riprap displacement from high water. Based upon levee inspections, it was determined the waterside levee slope is eroding, deteriorating, and degrading. The eroded levee sections need to be restored back to design standards to prevent further deterioration and damage. Site ID No: 577 Site Designation: LMA-483 Repair Type: Erosion Rating: Area of Concern Field Date: 8/10/2017 Notes:

LM Start	4.00	Rating **	A/W	Issue No.	19 (cont)
LM End	4.04	Issue Type +	Ma	Location *	WS
Category	Supplemental			GPS Latitude/Longitude	
				Start	End
Item	2017 Storm Damage			37.714048 °	37.714630 °
				-121.278363 °	-121.278263 °
DWR ID	DWR_RD2075_01_f_2017_19				
Comment Code					
Inspector Comment					
Levee Evaluation Comments					
Description:Slope protection repairs are needed along the waterside slope due to erosion and riprap displacement from high water. Based upon levee inspections, it was determined the waterside levee slope is eroding, deteriorating, and degrading. The eroded levee sections need to be restored back to design standards to prevent further deterioration and damage.					
Site ID No:577					
Site Designation:LMA-483					
Repair Type: Erosion					
Rating:Area of Concern					
Field Date:8/10/2017					
Notes:

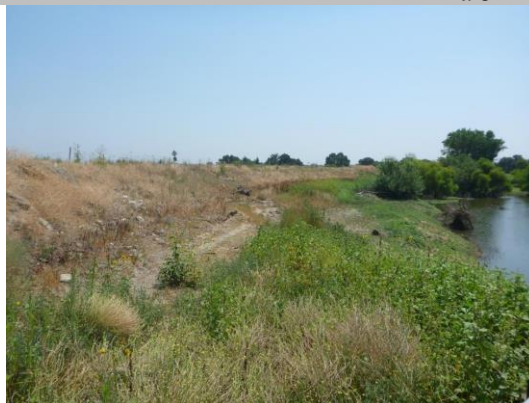
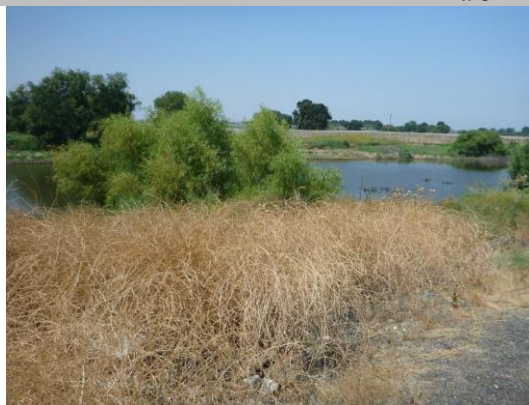
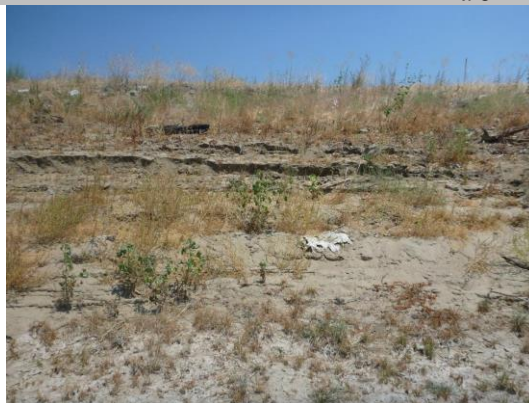
LM Start	5.24	Rating **	A/W	Issue No.	21
LM End	5.29	Issue Type +	Ma	Location *	WS
Category	Supplemental			GPS Latitude/Longitude	
				Start	End
Item	2017 Storm Damage			37.728460 °	37.727799 °
				-121.274671 °	-121.274252 °
DWR ID	DWR_RD2075_01_f _ 2017_21				
Comment Code					
Inspector Comment					
Levee Evaluation Comments					
Description:Slope protection repairs are needed along the waterside slope due to erosion and riprap displacement from high water. Based upon levee inspections, it was determined the waterside levee slope is eroding, deteriorating, and degrading. The eroded levee sections need to be restored back to design standards to prevent further deterioration and damage.					
Site ID No:578					
Site Designation:LMA-484					
Repair Type: Erosion					
Rating:Area of Concern					
Field Date:8/10/2017					
Notes: Paved road on levee.

LM Start	5.24	Rating **	A/W	Issue No.	21 (cont)
LM End	5.29	Issue Type +	Ma	Location *	WS
Category	Supplemental			GPS Latitude/Longitude	
				Start	End
Item	2017 Storm Damage			37.728460 °	37.727799 °
				-121.274671 °	-121.274252 °
DWR ID	DWR_RD2075_01_f_2017_21				
Comment Code					
Inspector Comment					
Levee Evaluation Comments					
Description:Slope protection repairs are needed along the waterside slope due to erosion and riprap displacement from high water. Based upon levee inspections, it was determined the waterside levee slope is eroding, deteriorating, and degrading. The eroded levee sections need to be restored back to design standards to prevent further deterioration and damage.					
Site ID No:578					
Site Designation:LMA-484					
Repair Type: Erosion					
Rating:Area of Concern					
Field Date:8/10/2017					
Notes: Paved road on levee.

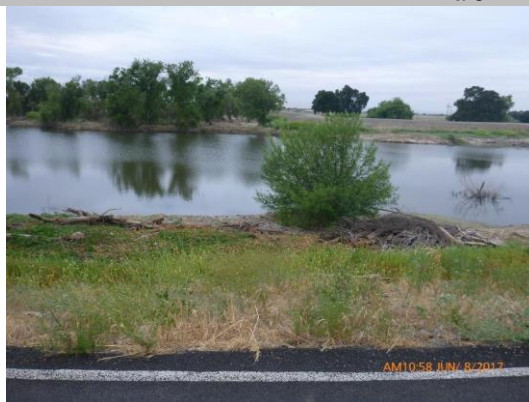
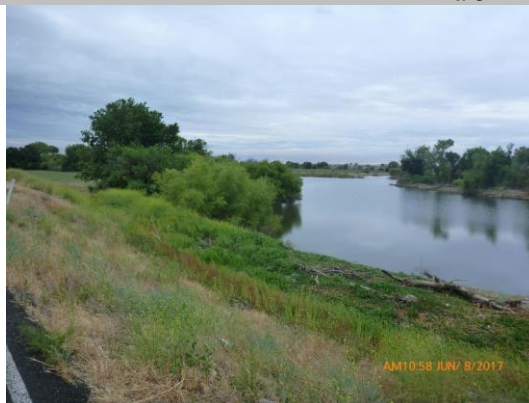
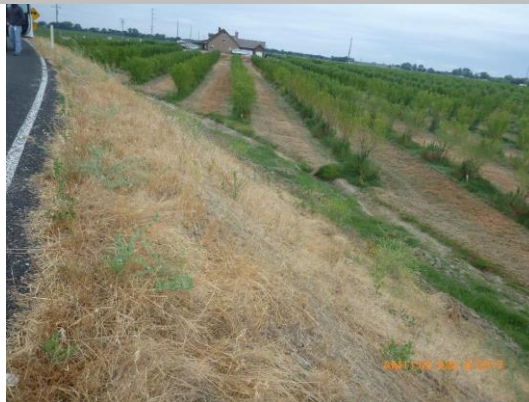
LM Start	5.26	Rating **	A/W	Issue No.	23
LM End		Issue Type +	Ma	Location *	WS
Category	Supplemental			GPS Latitude/Longitude	
				Start	End
Item	2017 Storm Damage			37.728216 °	°
				-121.274434 °	°
DWR ID	DWR_RD2075_01_f_2017_23				
Comment Code					
Inspector Comment					
Levee Evaluation Comments					
Description:					
Site ID No:79					
Site Designation:LMA-33					
Repair Type: Erosion					
Rating:Area of Concern					
Field Date:6/8/2017					
Notes: no damage present

LM Start	5.26	Rating **	A/W	Issue No.	23 (cont)	
LM End		Issue Type +	Ma	Location *	WS	
Category	Supplemental			GPS Latitude/Longitude		
				Start	End	
Item	2017 Storm Damage			37.728216°		°
				-121.274434°		°
DWR ID	DWR_RD2075_01_f_2017_23					
Comment Code						
Inspector Comment						
Levee Evaluation Comments						
Description:						
Site ID No:79						
Site Designation:LMA-33						
Repair Type: Erosion						
Rating:Area of Concern						
Field Date:6/8/2017						
Notes: no damage present

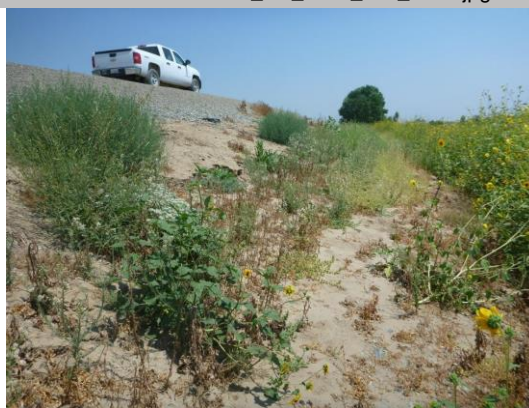
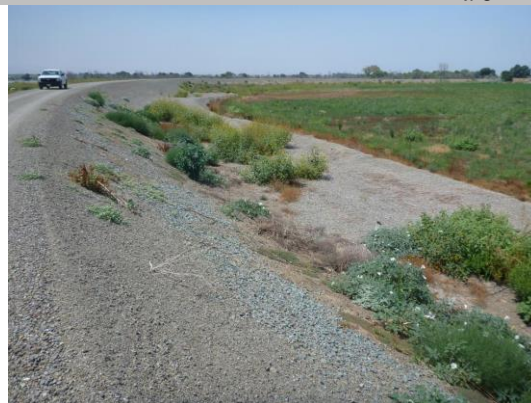
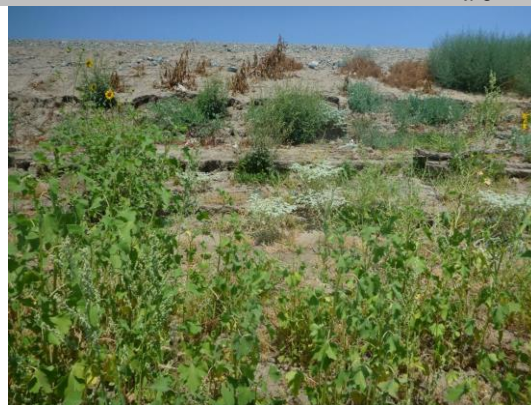
LM Start	5.87	Rating **	A/W	Issue No.	28
LM End	6.33	Issue Type +	Ma	Location *	WS
Category	Supplemental			GPS Latitude/Longitude	
				Start	End
Item	2017 Storm Damage			37.721710 °	37.720960 °
				-121.267490 °	-121.259830 °
DWR ID	DWR_RD2075_01_f _ 2017_28				
Comment Code					
Inspector Comment					
Levee Evaluation Comments					
Description:Slope protection repairs are needed along the waterside slope due to erosion and riprap displacement from high water. Based upon levee inspections, it was determined the waterside levee slope is eroding, deteriorating, and degrading. The eroded levee sections need to be restored back to design standards to prevent further deterioration and damage.					
Site ID No:579					
Site Designation:LMA-485					
Repair Type: Erosion					
Rating:Area of Concern					
Field Date:8/10/2017					
Notes: Berm present on LS. LMA 486 is combined with this site.

Comment Code					
Inspector Comment					
Levee Evaluation Comments					
Description:Slope protection repairs are needed along the waterside slope due to erosion and riprap displacement from high water. Based upon levee inspections, it was determined the waterside levee slope is eroding, deteriorating, and degrading. The eroded levee sections need to be restored back to design standards to prevent further deterioration and damage.					
Site ID No:579					
Site Designation:LMA-485					
Repair Type: Erosion					
Rating:Area of Concern					
Field Date:8/10/2017					
Notes: Berm present on LS. LMA 486 is combined with this site.
